CALSPAN ON-SITE AIR BAG/CHILD FATALITY INVESTIGATION

CALSPAN CASE NO. 96-16

VEHICLE : 1996 DODGE CARAVAN

LOCATION: FLORIDA

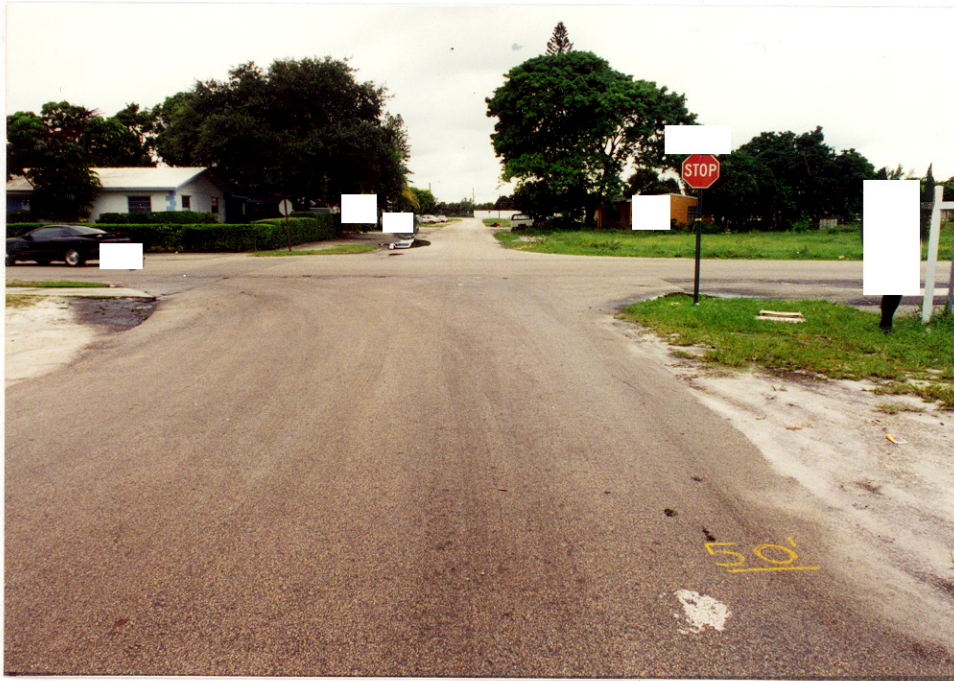
2. Trajectory of the Dodge Caravan at 30 m (100') prior to impact.

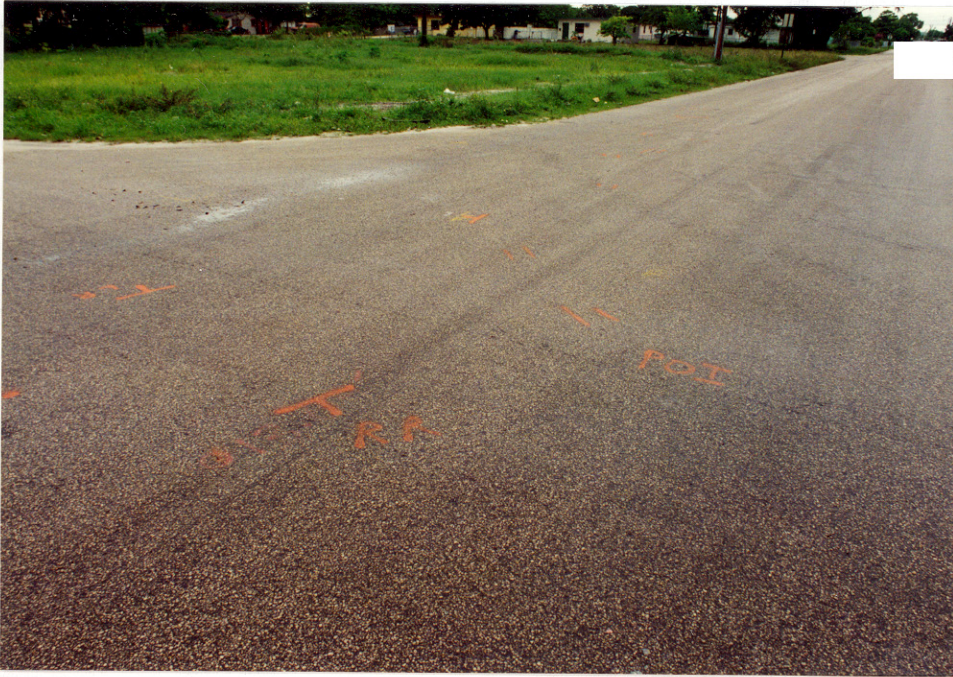
4. Point of impact.

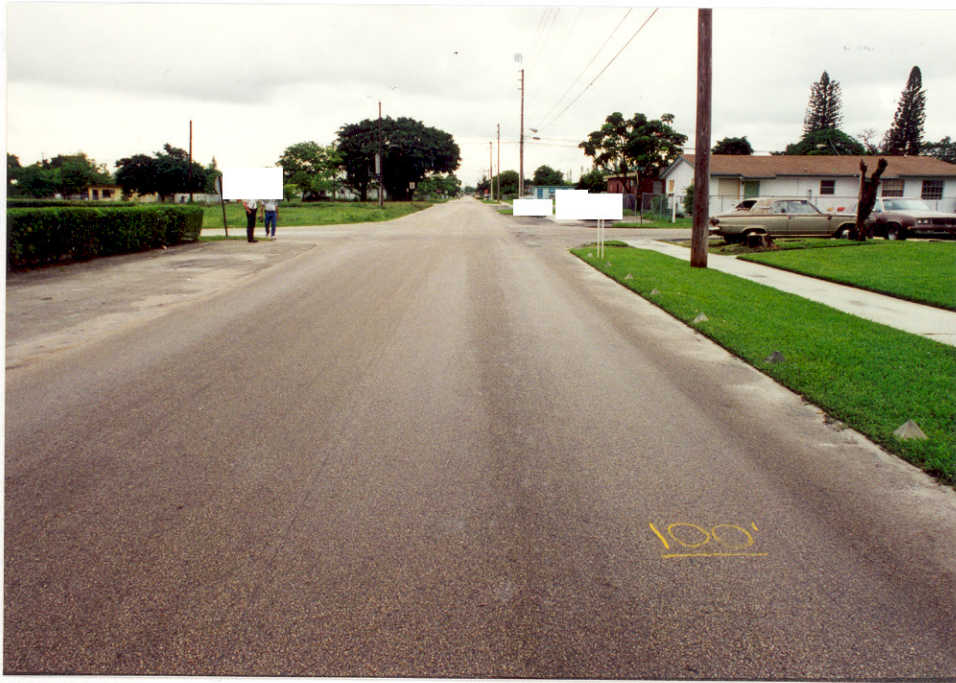
6. Lookback view of the Dodge Caravan's path of travel.

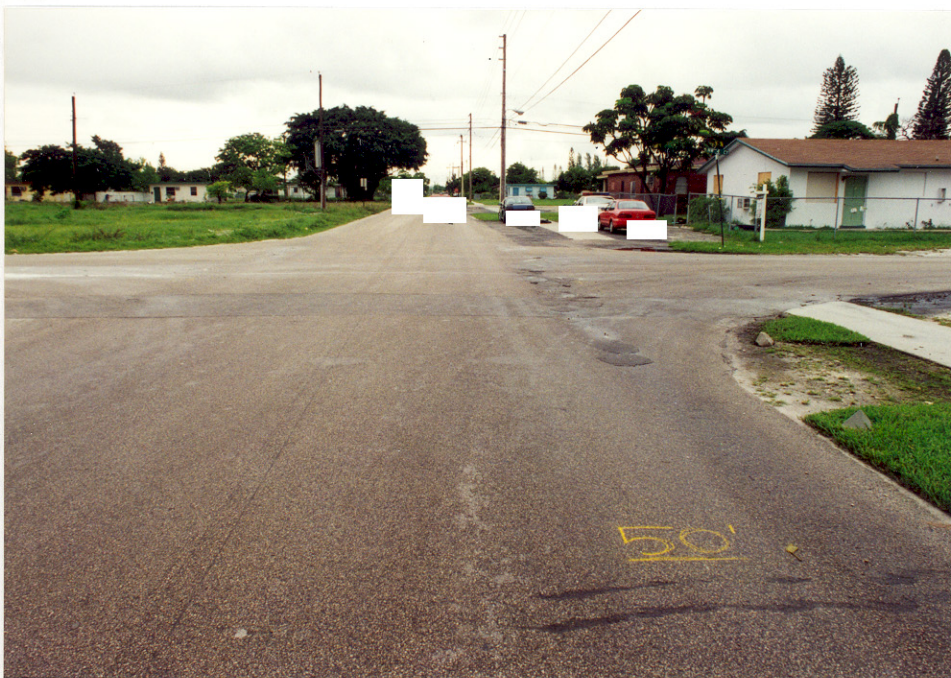
7. Pre-crash trajectory of the 1966 Chevrolet Impala at 30 m (100') prior to impact.

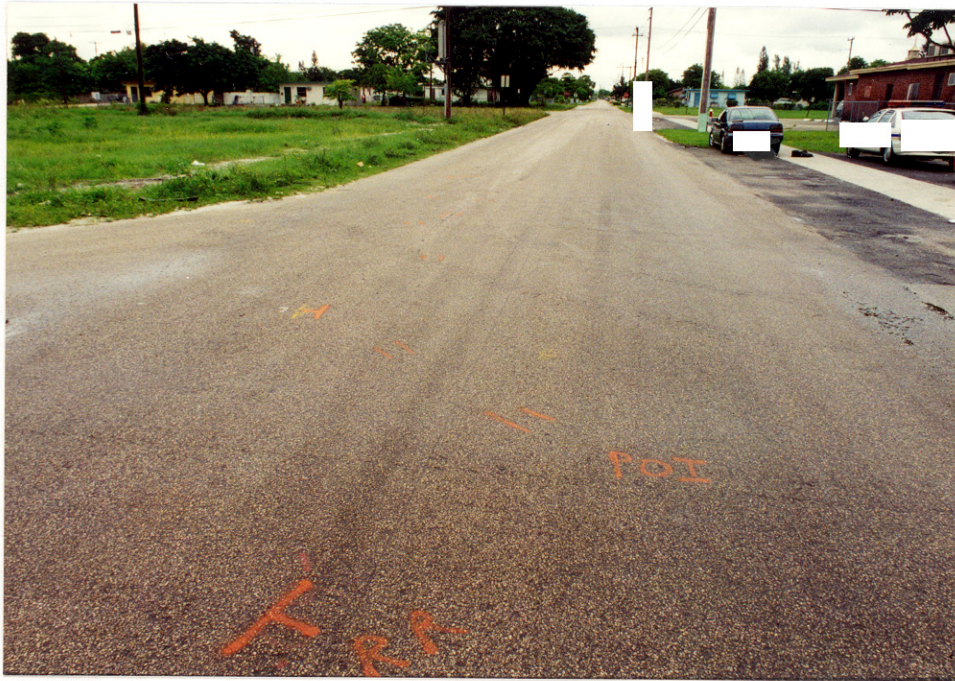
8. Trajectory of the Chevrolet Impala at 15 m (50') prior to impact.

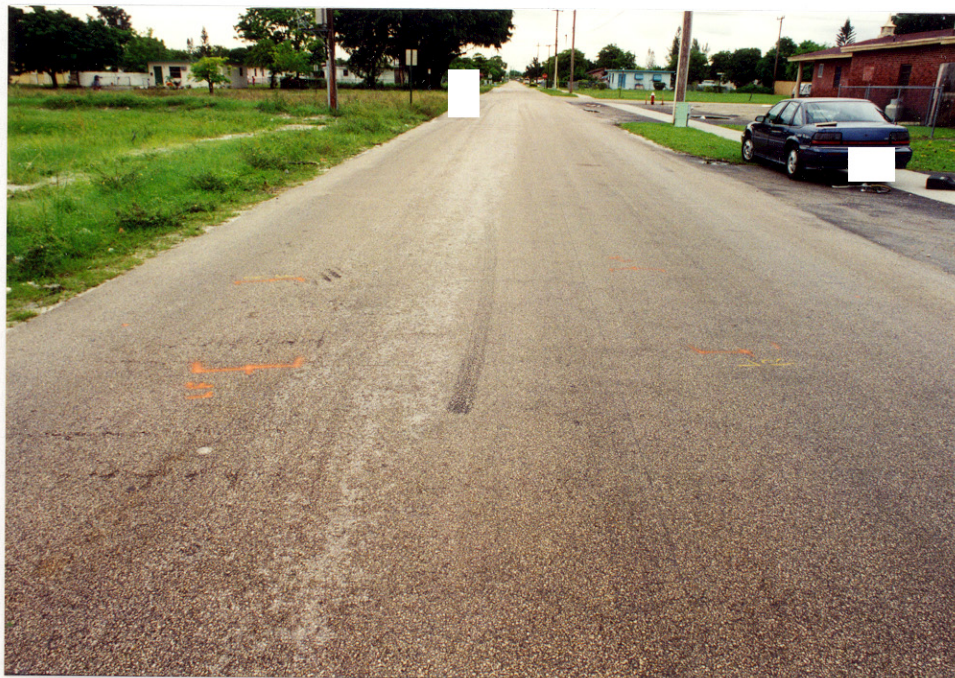
9. Trajectory of the Chevrolet Impala at point of impact.

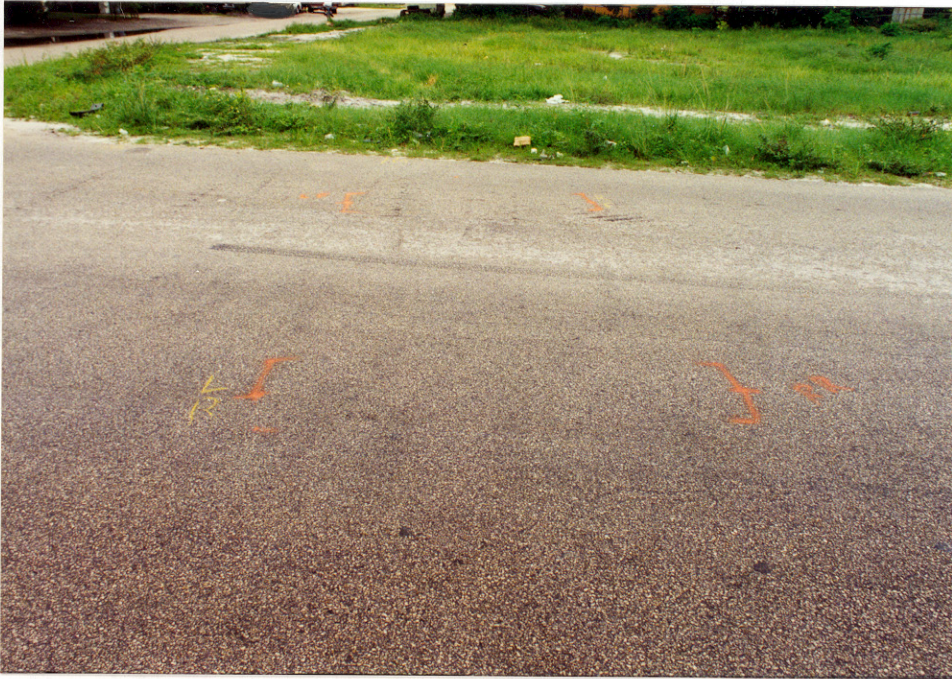
10. Final rest of the Chevrolet Impala.

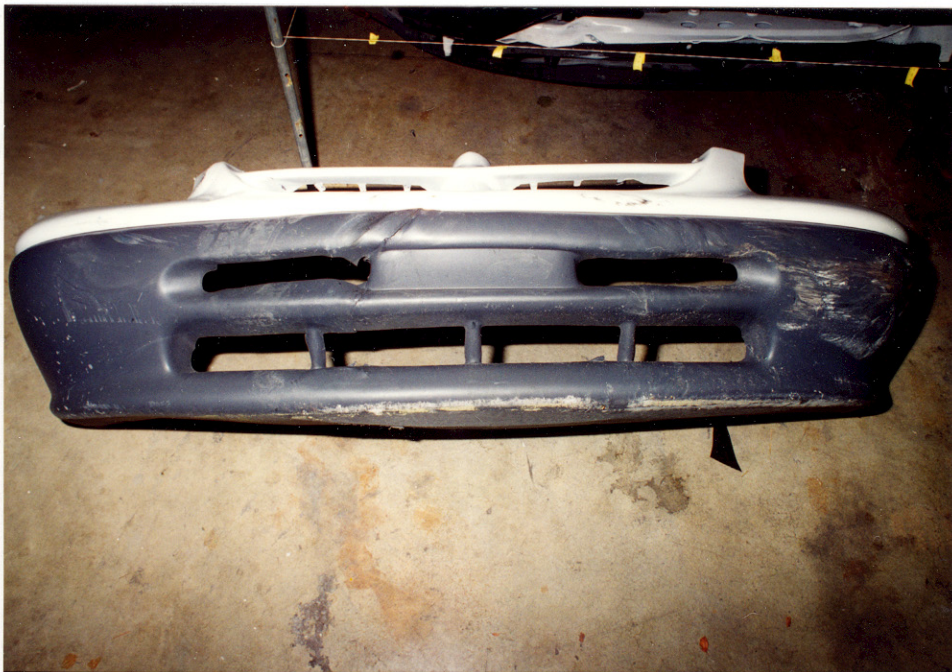
The full frontal area of the Dodge Caravan impacted the right rear quarter panel of the 1966 Chevrolet Impala which resulted in moderate damage to the Caravan. The impact separated the front bumper fascia from the reinforcement bar, therefore the crush profile was documented at the face of the reinforcement bar. Maximum crush was 32.4 cm (12.75") located 12.1 cm (4.75") right of the vehicle's centerline. The crush values at the bumper reinforcement bar were as follows: C₁= 4.1 cm (1.6"), C₂= 16.3 cm (6.4"), C₃= 26.9 cm (10.1"), C₄= 32.4 cm (12.75"), C₅= 16.0 cm (6.3"), C₆= 11.7 cm (4.6").

13. Frontal view of the impact damage to the 1996 Dodge Caravan.

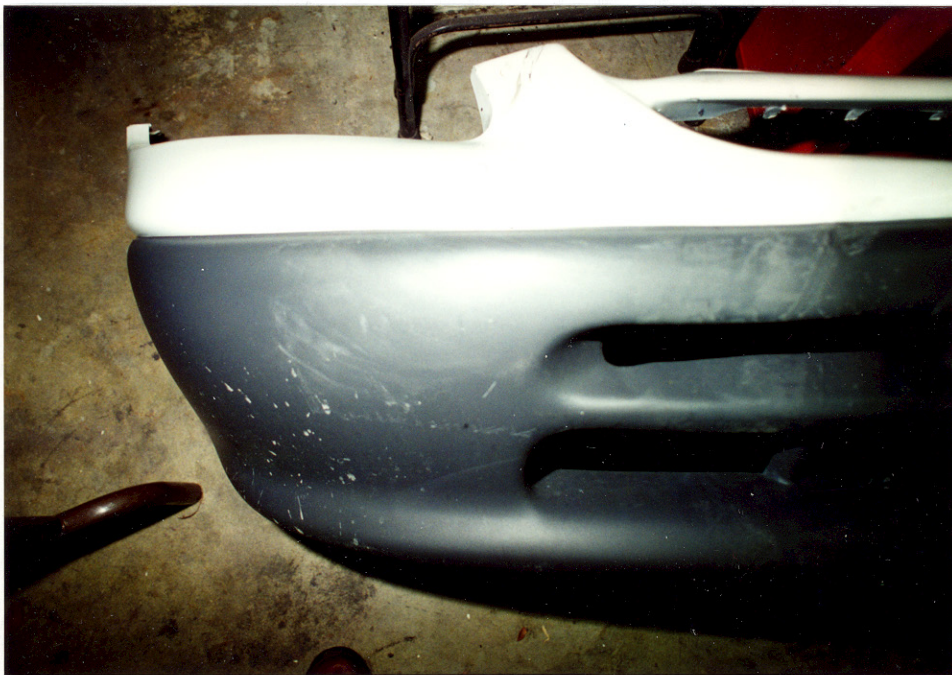
14. View of the front bumper fascia of the Dodge Caravan.

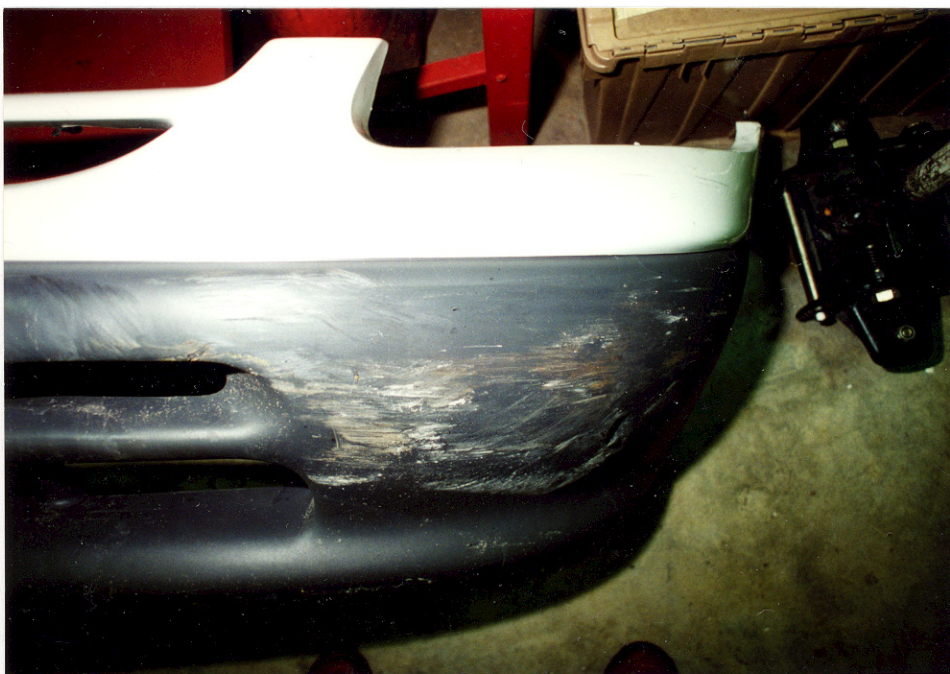
15. Close-up view of the damage to the right corner of the front bumper fascia.

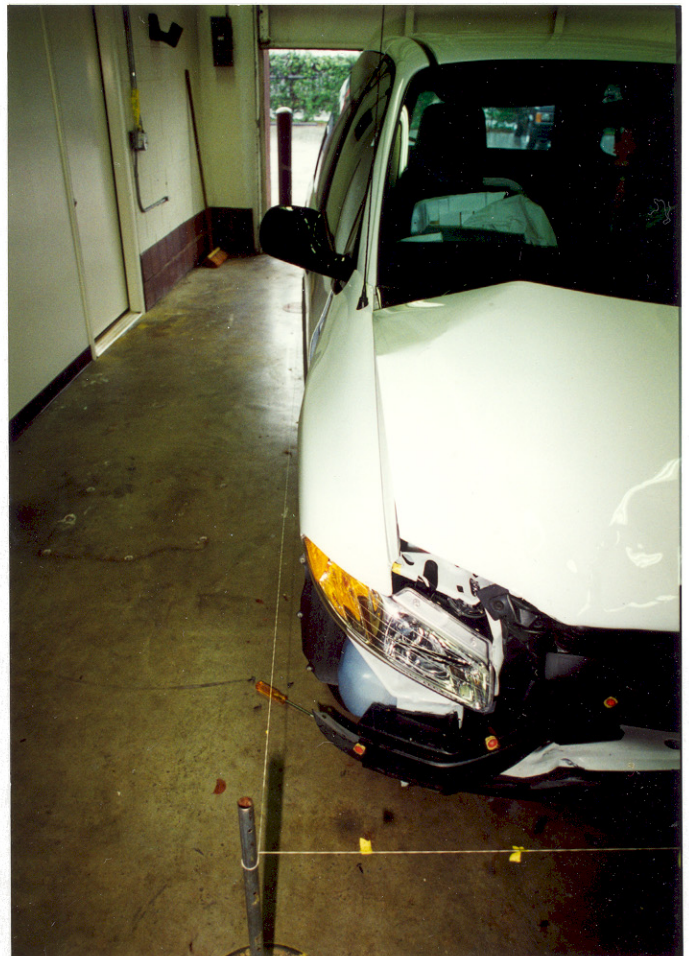
18. Longitudinal view of the lateral displacement of the right front corner.

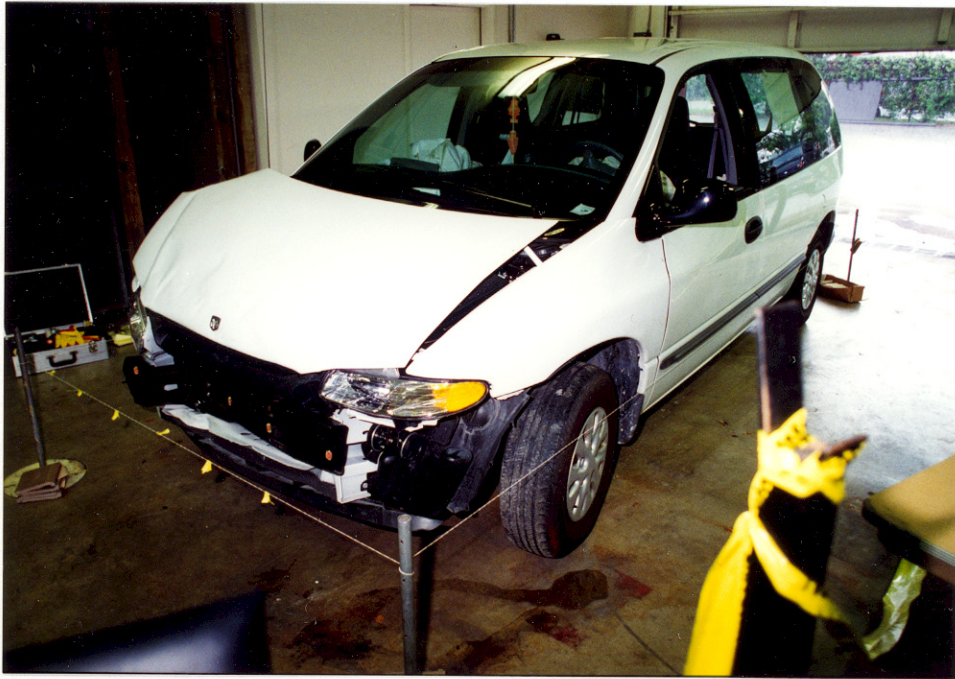
20. Close-up view of the maximum crush to the bumper reinforcement bar of the Dodge Caravan.

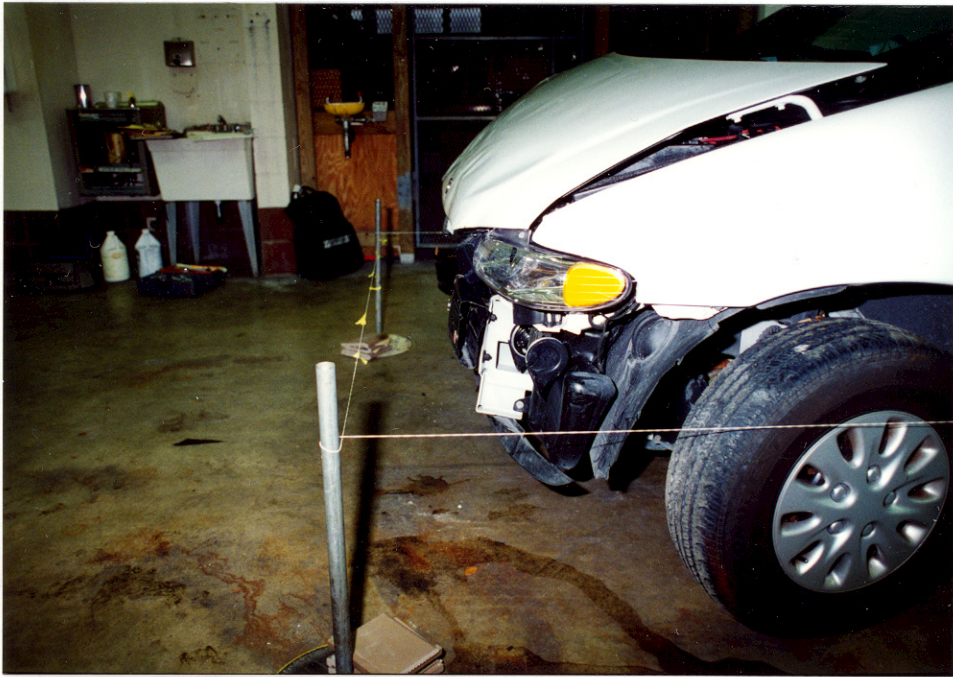
Components damaged by the crash included the front bumper fascia, bumper reinforcement bar, grille, hood, upper radiator support panel, and the right front fender.

22. Overhead view of the damage to the bumper reinforcement bar and upper radiator support bracket.

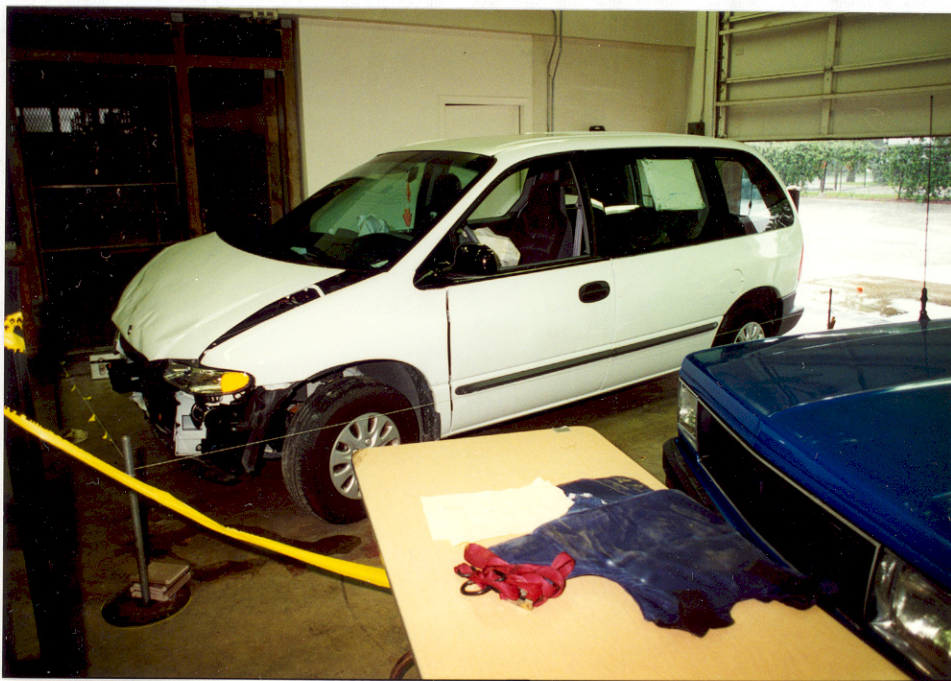
24. Perpendicular view of the rearward displacement of the bumper reinforcement bar and upper radiator support bracket.

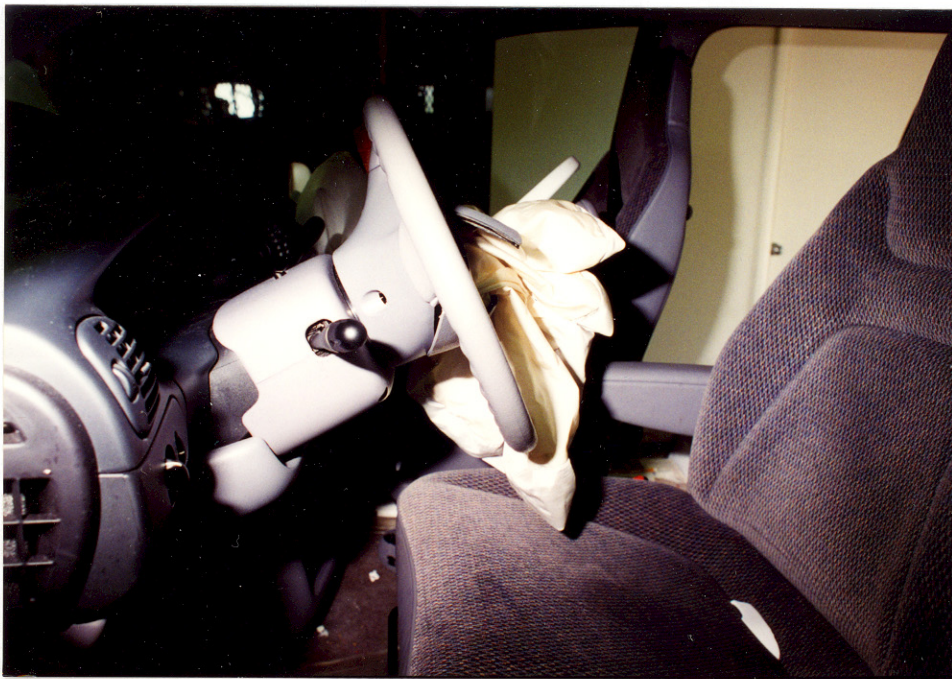
34. View of the driver side air bag module cover flaps.

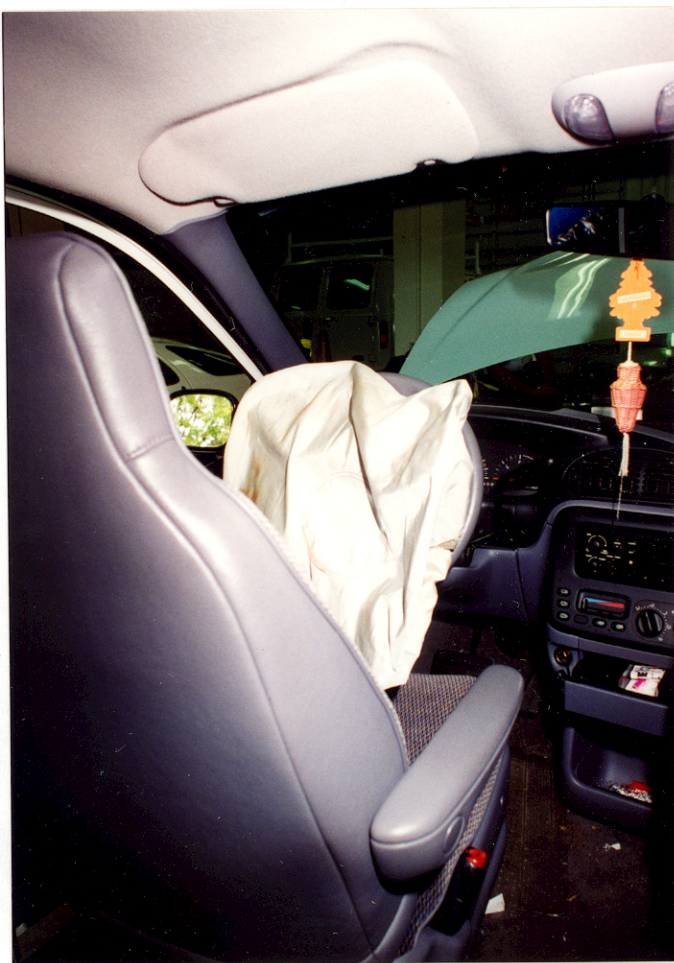
38. View of the deployed driver side air bag and sun visor.

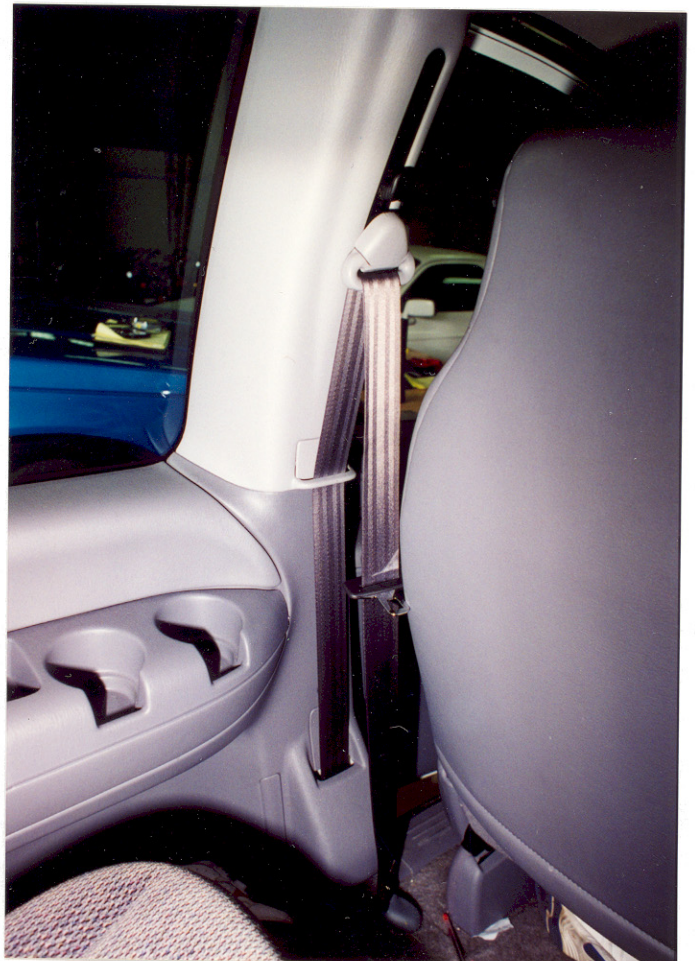
42. Driver's side manual 3-point seat belt system with D-ring adjusted to full down position.

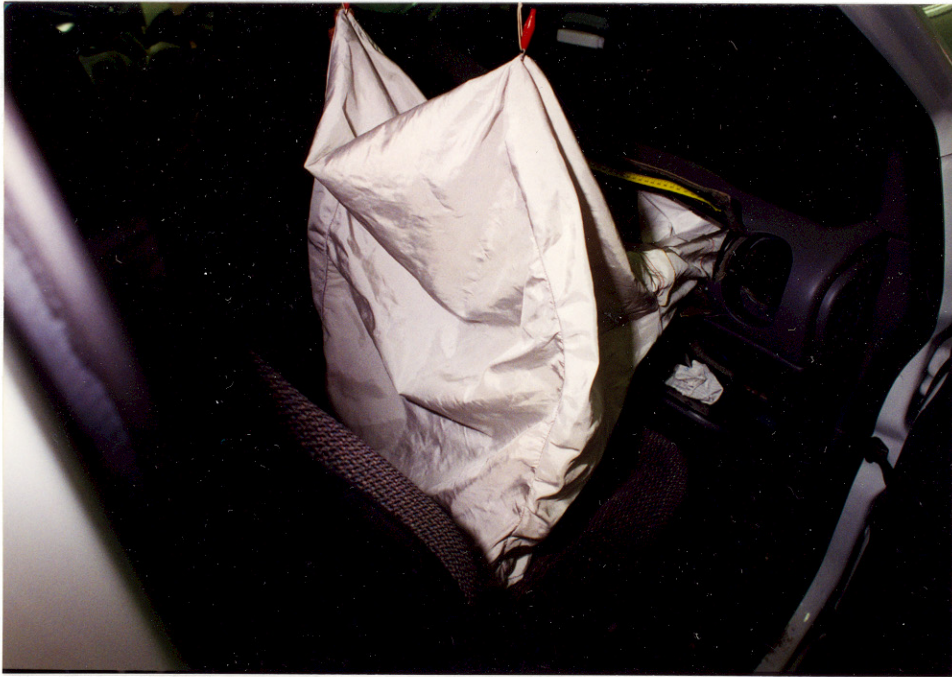
The passenger side air bag deployed from the symmetrical flap configuration module that was mounted within the mid instrument panel of the vehicle. The passenger side air bag membrane and the upper module cover flap exhibited evidence of contact with the back side of the rearward-facing Century infant restraint. A 5.1 cm (2.0") vertically oriented tear was noted to the bottom panel of the passenger side air bag. The frayed fabric ends were singed from the hot gas venting through the tear point. The contact evidence is identified in the Automatic Restraint System section of this report.

46. Close-up view of the deployed passenger side air bag and cover flaps, right instrument panel, and the opened glove compartment door.

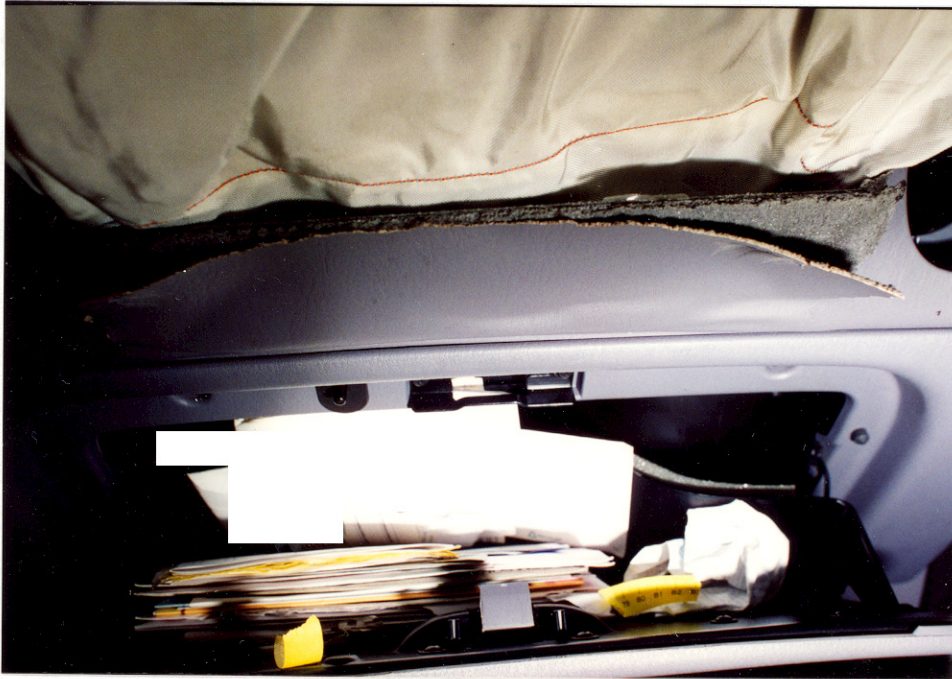
52. Child restraint white vinyl transfers on the upper cover flap.

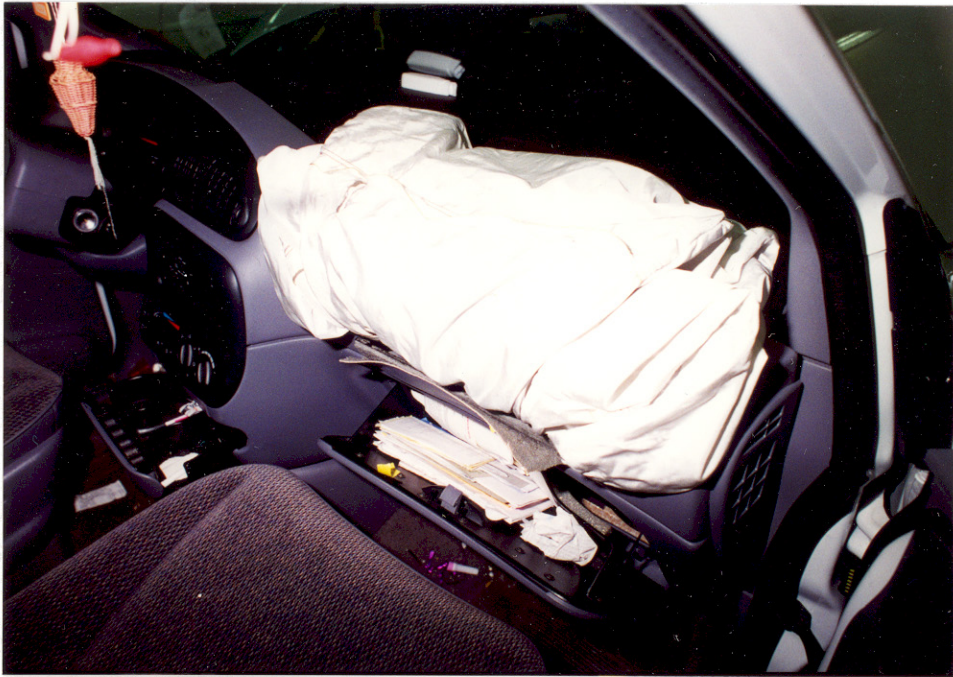
54. Overall view of the passenger side air bag.

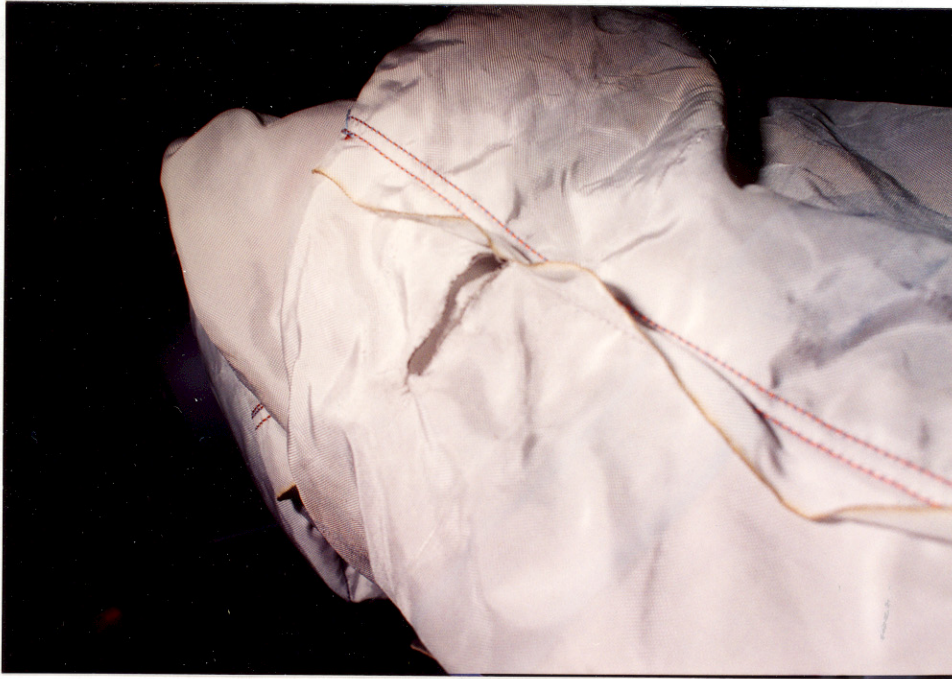
58. Close-up view of the blue cloth transfer.

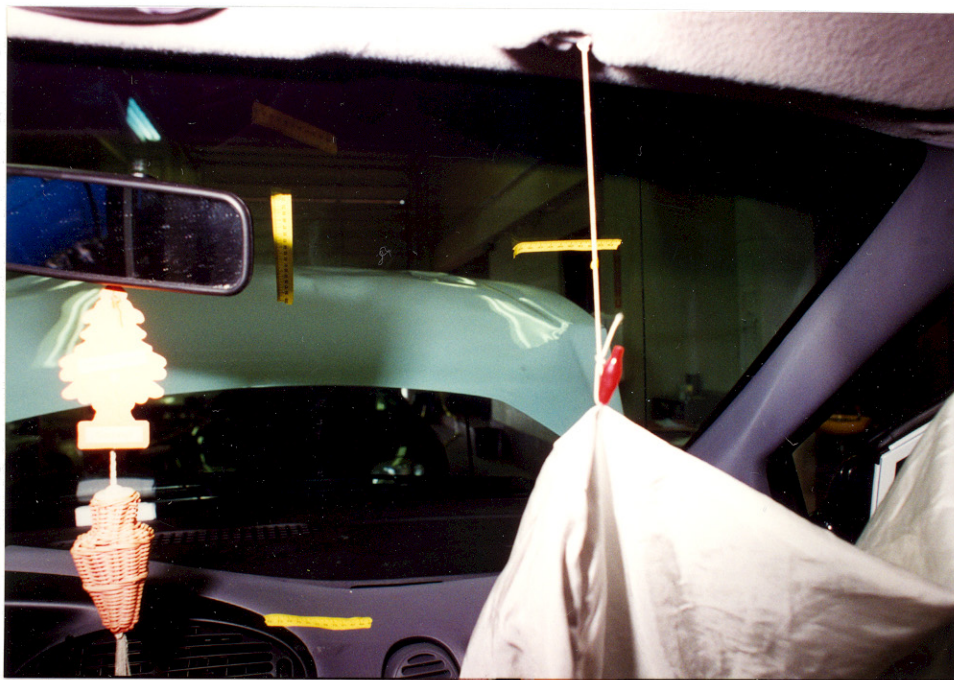
The passenger side air bag was a non-tethered bag with no vent ports. The bag probably exhausted through the porous membrane. The rearward excursion of the passenger side air bag was 58.4 cm (23.0") from the module and 45.7 cm (18.0") from the protruding mid instrument panel. The throat of the bag extended 25.4 cm (10.0") outboard of the inflator to the seam attaching the bag to the inflator assembly. The wide band of stitching was used as a reference point to locate contact evidence that was observed on the bag. The vertical height of the face of the bag was 68.6 cm (27.0") and the width was 47.0 cm (18.5"). Vertically oriented blue cloth transfers were noted on the passenger side air bag from contact with the fabric liner of the child restraint. A 5.1 cm (2.0") long vertical tear was located on the left side of the bag at the stitched seam. The frayed edges of the tear were scorched from the hot gas exhausting from the bag (refer to Photograph No. 59).

59. Close-up view of the 5.1 cm (2.0") vertical tear on the left side of the passenger side air bag.

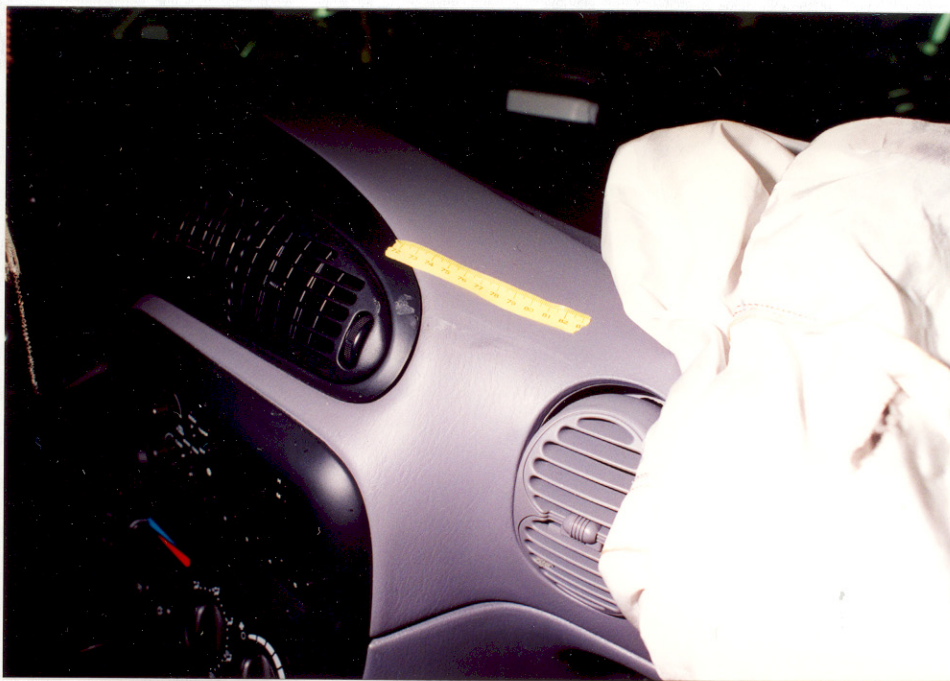
In addition to the passenger side air bag contact evidence, an oily semi-circular transfer was located on the windshield 12.7-19.7 cm (5.0-7.75") right of center and 33.0-43.2 cm (13.0-17.0") above the top surface of the upper instrument panel. An inverted U-shaped transfer, which was a possible passenger side air bag fabric transfer, was located on the windshield 33.0-39.4 cm (13.0-15.5") right of center and 40.6-45.7 cm (16.0-18.0") above the top surface of the upper instrument panel. A horizontal white vinyl transfer was noted to the black plastic trim of the mid instrument panel and the center vent louver located 10.2-16.5 cm (4.0-6.5") right of center. This transfer resulted from probable contact by the carrying handle rear facing child restraint. Body fluid stains (blood) were noted on the right front lap belt segment that extended across the rearward-facing child restraint. The stains were located 69.9-88.9 cm (27.5-35.0") above the floor anchorage. The glove compartment door was open at the time of inspection and the right vent louver was separated from its instrument panel mount. Both components were displaced from distortion of the instrument panel which resulted from the deployment of the passenger side air bag system against the restraint. The fabric headliner above the right front seat had two small tears which probably resulted from fragments of the plastic shell of the child restraint.

60. Grease-type semi-circular transfer and possible white vinyl transfer on windshield right of center.

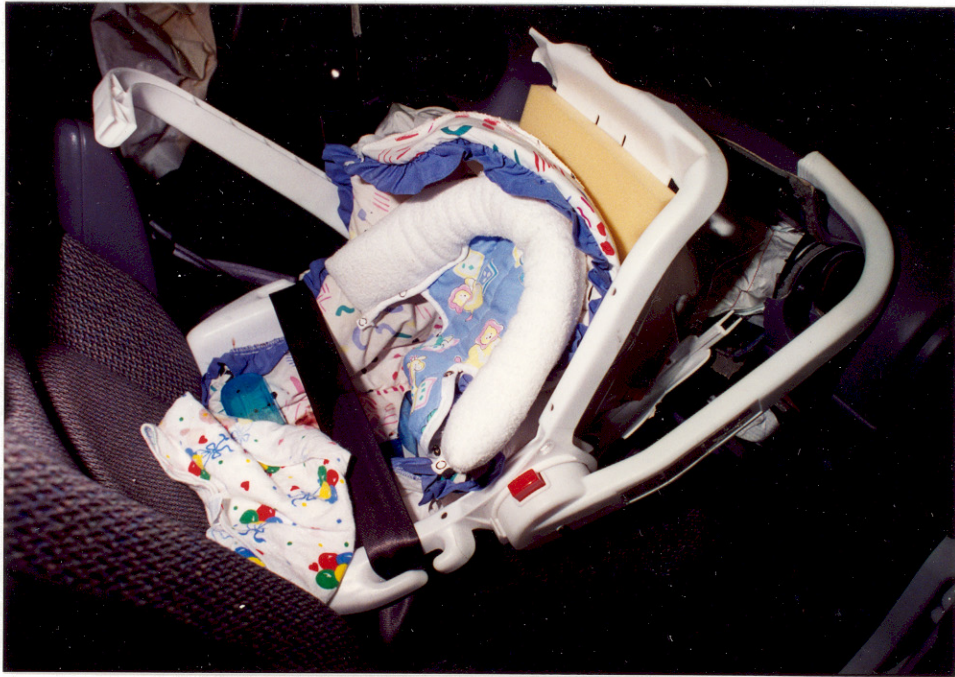
The 7 week old female passenger was positioned in a rearward-facing Century Model ~~XXXXXX~~ infant restraint. She was probably properly secured by the integral 3-point harness. Although the position of the infant in the restraint was not witnessed by emergency personnel on-scene, blood stains on the webbing supported usage of the harness system. The infant restraint was secured in the right front passenger seat by the manual lap belt. The manual belt webbing was positioned through the upper loops of the child restraint. The D-ring for the right front belt system was adjusted to the lowest position. The restraint was designed with a detachable base, however, the base was not used. The base was found in the rear floor area of the vehicle. The right front seat track was adjusted to the full forward track position with the seat back reclined to 25 degrees at the lumbar support region. This seat track position placed the upper aspect of the infant restraint against the mid-mount passenger side air bag module assembly with the infant's head resting in the vicinity of the air bag module cover flaps.

68. Position of the rearward facing child restraint in the right front seat position.

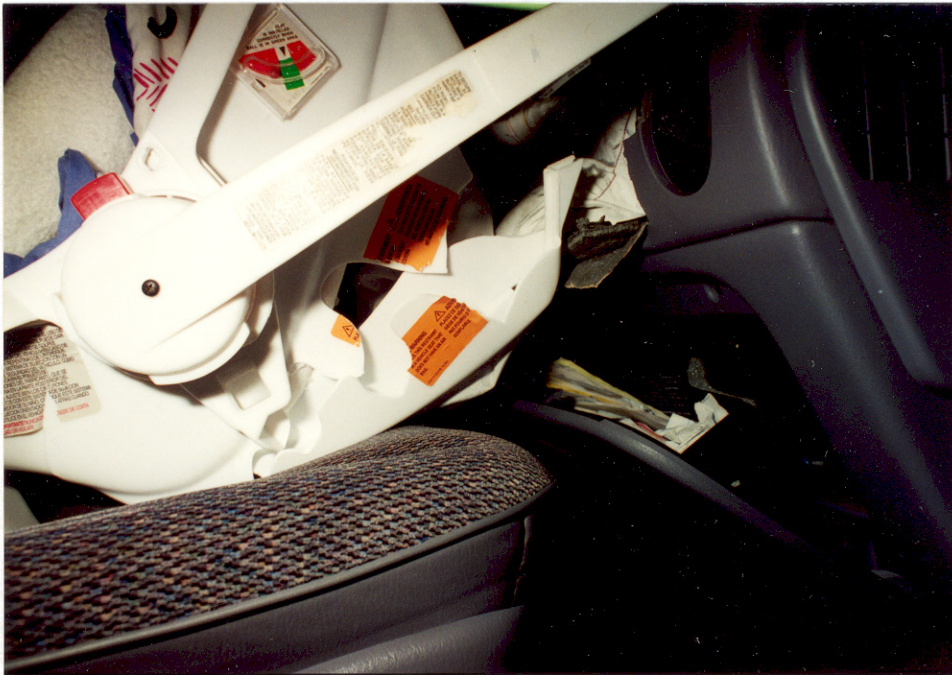
The restraint was positioned between the seat back support and the mid mount passenger side air bag module assembly. At impact, the deploying air bag and symmetrical cover flaps contacted the upper aspect of the shell. The contact fractured the shell in both the vertical and longitudinal directions. The lower outboard aspect of the restraint had a 21.6 x 17.8 cm (8.5 x 7.0") section that was completely separated from the shell.

70. Close-up view of the child restraint positioned against the panel and mid-mount air bag module assembly.

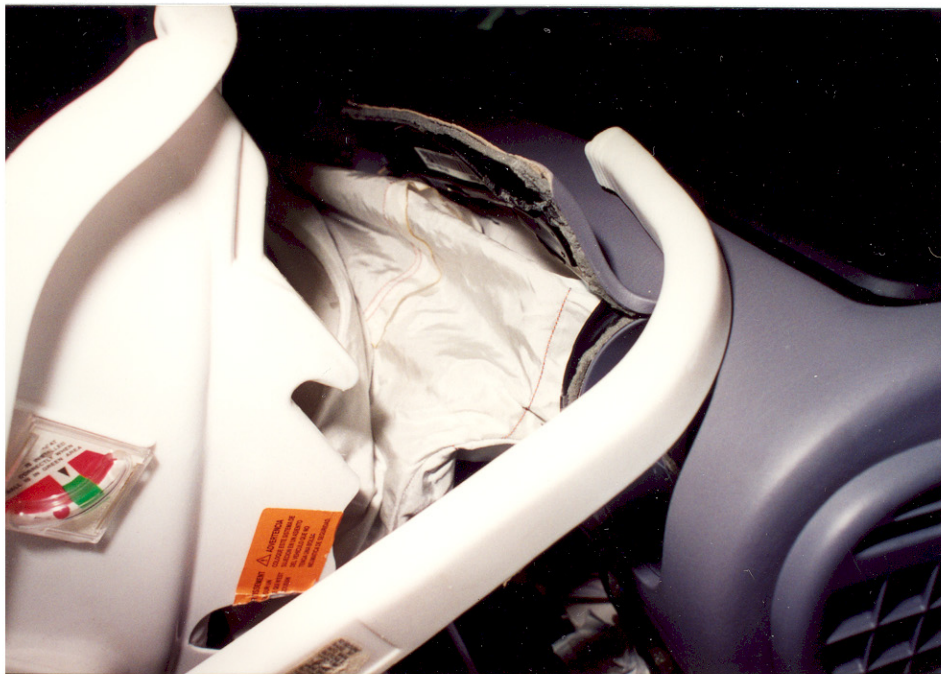
At impact, the driver and passenger side air bag system deployed. The passenger side air bag module cover flaps opened against the back side of the plastic shell of the rearward-facing infant restraint. The symmetrical H-configuration module cover flaps, in combination with the deploying air bag membrane, fractured the back side of the plastic shell of the infant restraint and accelerated the restraint in a rearward direction with respect to the vehicle. White vinyl-type transfers were noted across the full width of the upper module cover flap. Two similar transfers were noted to the upper corner areas of the lower cover flap. The deploying air bag subsequently contacted the shell of the restraint, which in combination with the cover flap contact, severely fractured the restraint in both the lateral and longitudinal directions.

71. View of the plastic shell fracture caused by the air bag module cover flaps.

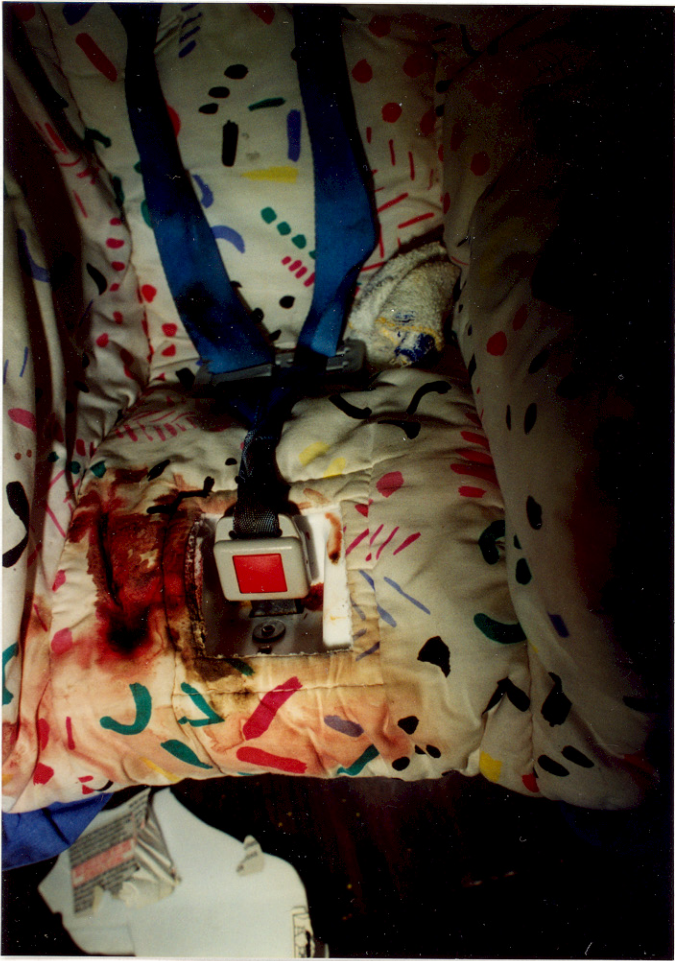
84. Close-up view of the Century child restraint and integral 3-point harness.

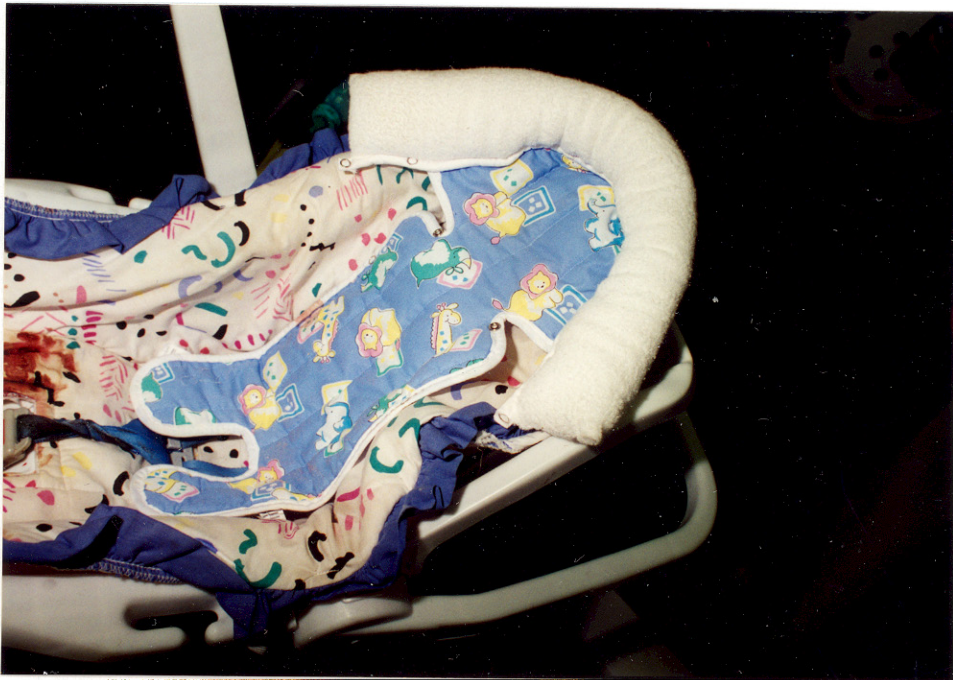
85. Additional view of the three-point restraint harness with chest clip and center buckle assembly.

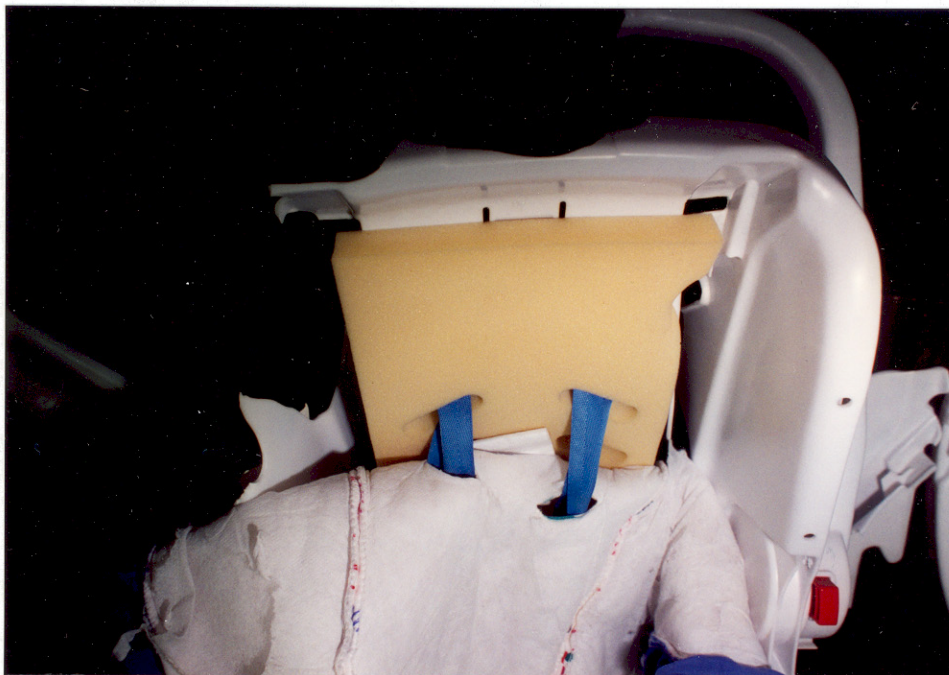
94. Shoulder harness adjustment straps positioned through slots for larger infants.

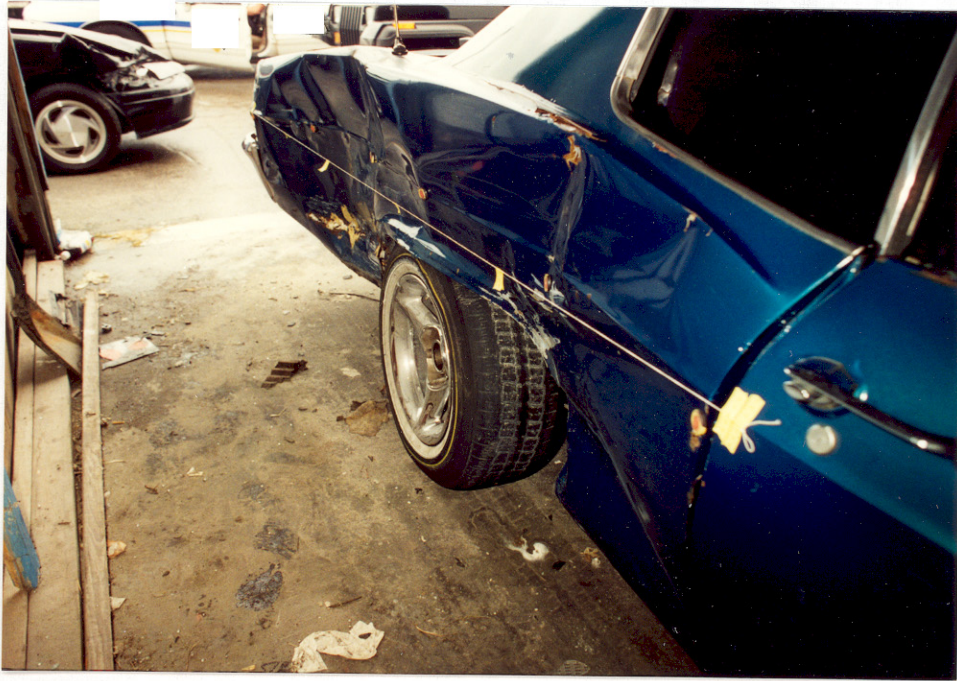
The Chevrolet Impala sustained moderate damage to the right rear quarter panel from its impact sequence with the Dodge Caravan. Maximum crush was 15.2 cm (6.0") located 41.9 cm (16.5") forward of the right rear axle. The direct contact damage began 72.4 cm (28.5") forward of the right rear axle and extended 188.0 cm (74.0") rearward. The combined induced and direct contact damage began at the left B-pillar and extended 215.6 cm (84.9") rearward to the trailing end of the quarter panel. The crush profile was documented at a height of 61.0 cm (24.0") above ground level (mid-door level) and was as follows: $C_1 = 0$ cm (0"), $C_2 = 13.3$ cm (5.25"), $C_3 = 11.4$ cm (4.5"), $C_4 = 8.6$ cm (3.4"), $C_5 = 13.3$ cm (5.25"), $C_6 = 1.9$ cm (0.75").

106. Longitudinal view showing the depth of crush to the right rear quarter panel of the Chevrolet Impala.

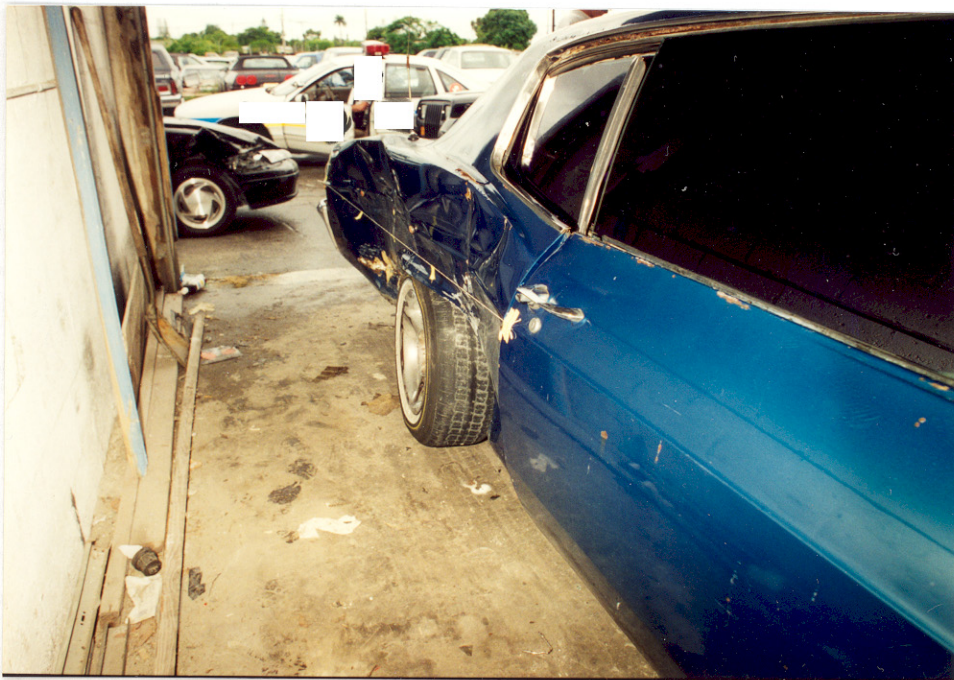
107. View of the impact damage to the Chevrolet Impala.
